## RICHMOND CONSERVATION STUDIO

### **Report of Examination and Conservation Treatment:**

**Object:** Altarpiece of St. Peter's Episcopal Church, Port Royal, Virginia

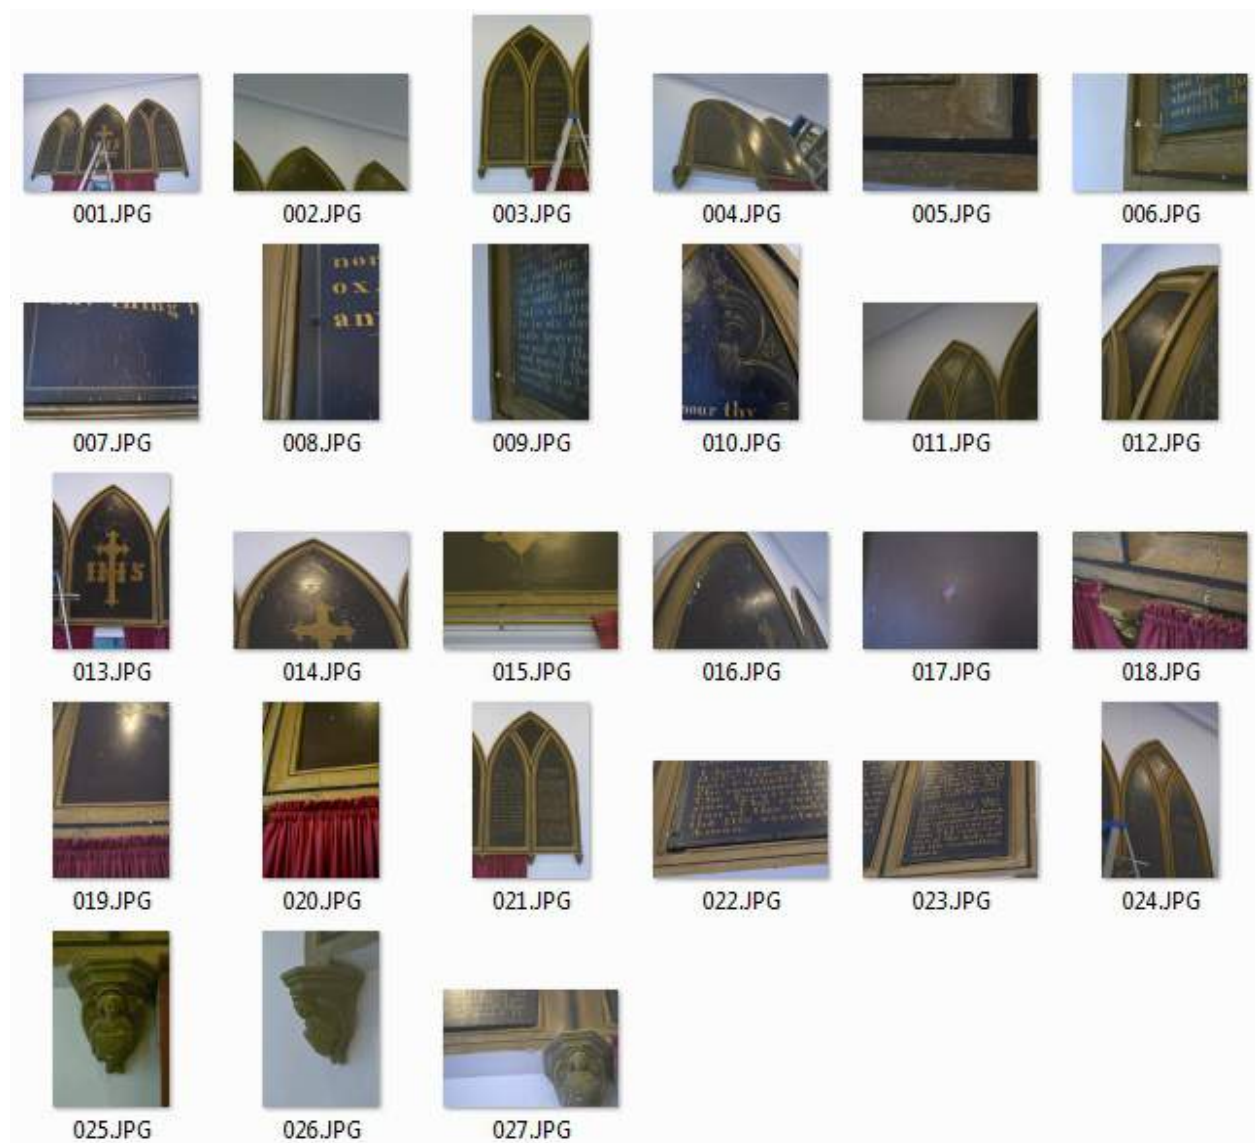
*September 18, 2014 photographs -*

- 001. Altarpiece
- 002. Drip marks on upper wall
- 003 - 010. Ten Commandments tablets
- 011 - 012. Pinnacle on Ten Commandments tablets
- 013 - 020. Central panel
- 021 - 023. Right pair of panels
- 024. Pinnacle on right pair of tablets
- 025 - 027. Angel corbels

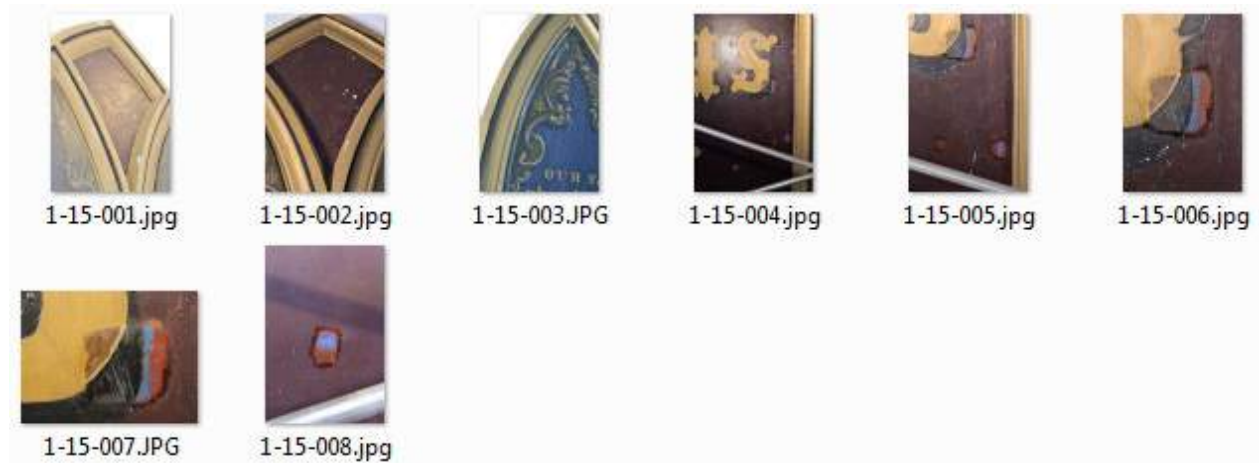
*February 3, 2015 photographs -*

- 1-15-001. Right pinnacle
- 1-15-002. Right pinnacle with test cleaning
- 1-15-003. Blue paint on wall, glimpsed behind the Lord Prayer tablet
- 1-15-004. Test cleanings made in the lower right quadrant of the central panel
- 1-15-005. Test cleanings made in the lower right quadrant of the central panel
- 1-15-006. Test cleaning made in the *S* on the central panel
- 1-15-007. Test cleaning made in the *S* on the central panel
- 1-15-008. Test cleaning made in the background, lower right edge on the central panel

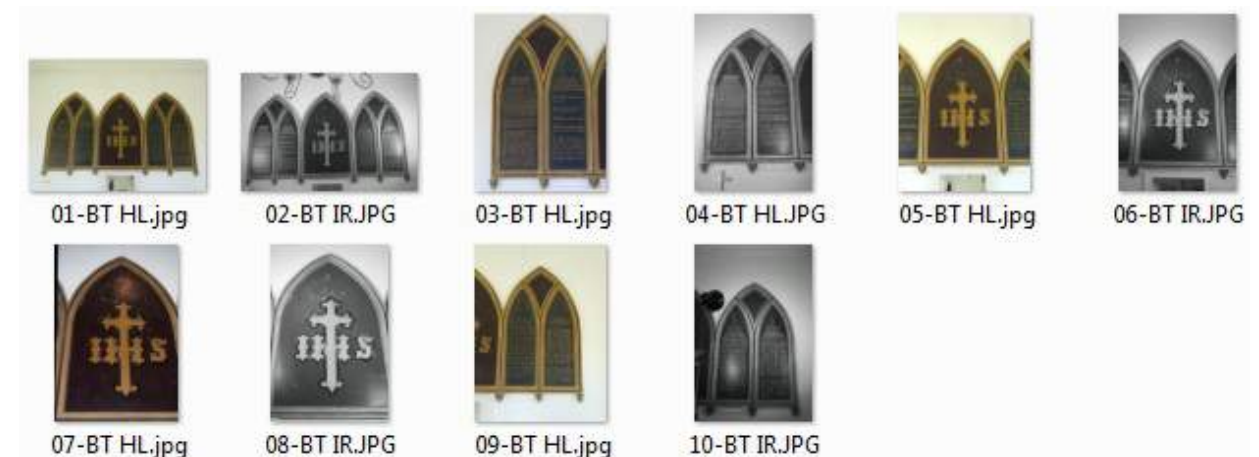
*April 13, 2016 photographs -*

- 01. Ten Commandments panels
- 02. Ten Commandments panels, B&W infra-red reflectance
- 03. Central panel
- 04. Central panel, B&W infra-red reflectance
- 05. Central panel, B&W infra-red reflectance
- 06. Lord's Prayer and Nicene Creed panels
- 07. Lord's Prayer and Nicene Creed panels, B&W infra-red reflectance

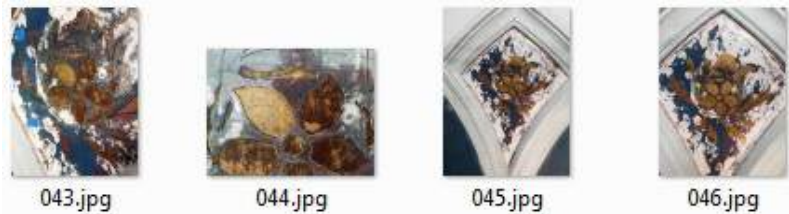
*during inpainting -  
(left pinnacle)*

- 043. detail of center with stencil in place
- 044. detail of flower with stencil
- 045. full view, after stenciling
- 046. full view, after stenciling

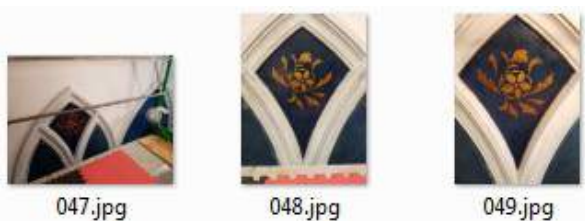
*after inpainting -  
(left pinnacle)*

- 047. view from top level of scaffolding
- 048. full view
- 049. full view

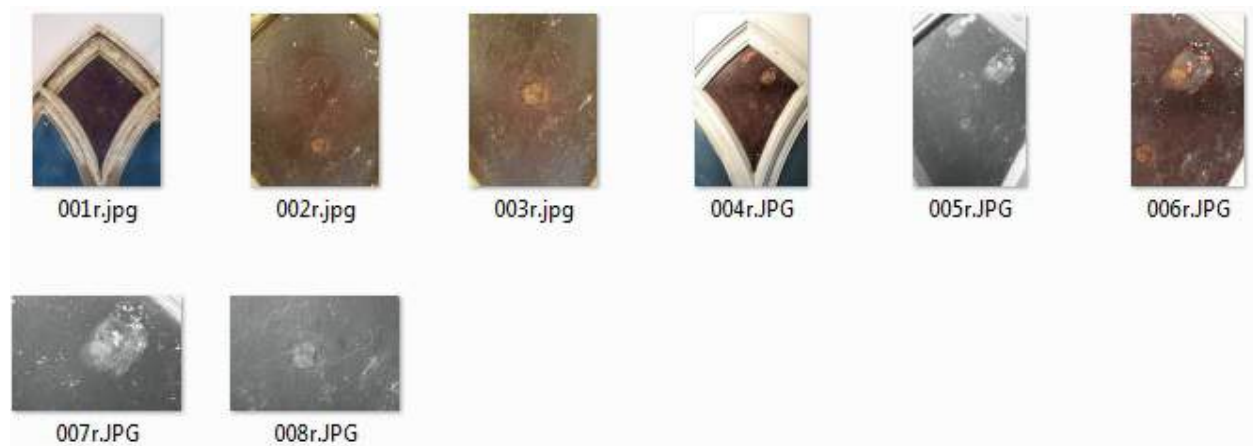
*before treatment - (right pinnacle)*

- 001r. full view with test cleaning
- 002r. detail, center with test cleaning
- 003r. detail of test cleaning
- 004r. full view, more test cleanings
- 005r. detail, center, infra-red reflectance
- 006r. detail of test cleaning
- 007r. detail of upper test cleaning, infra-red reflectance
- 008r. detail of lower test cleaning, infra-red reflectance

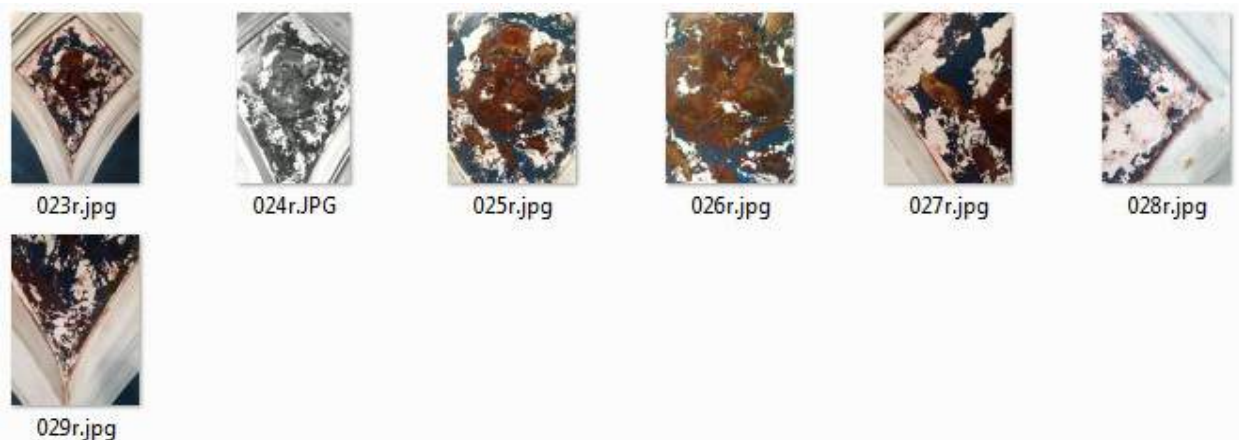
*during filling -  
(right pinnacle)*

- 023r. full view
- 024r. full view, infra-red reflectance
- 025r. detail of center
- 026r. detail, flower, center
- 027r. detail of middle left
- 028r. detail of middle right
- 029r. detail of lower section

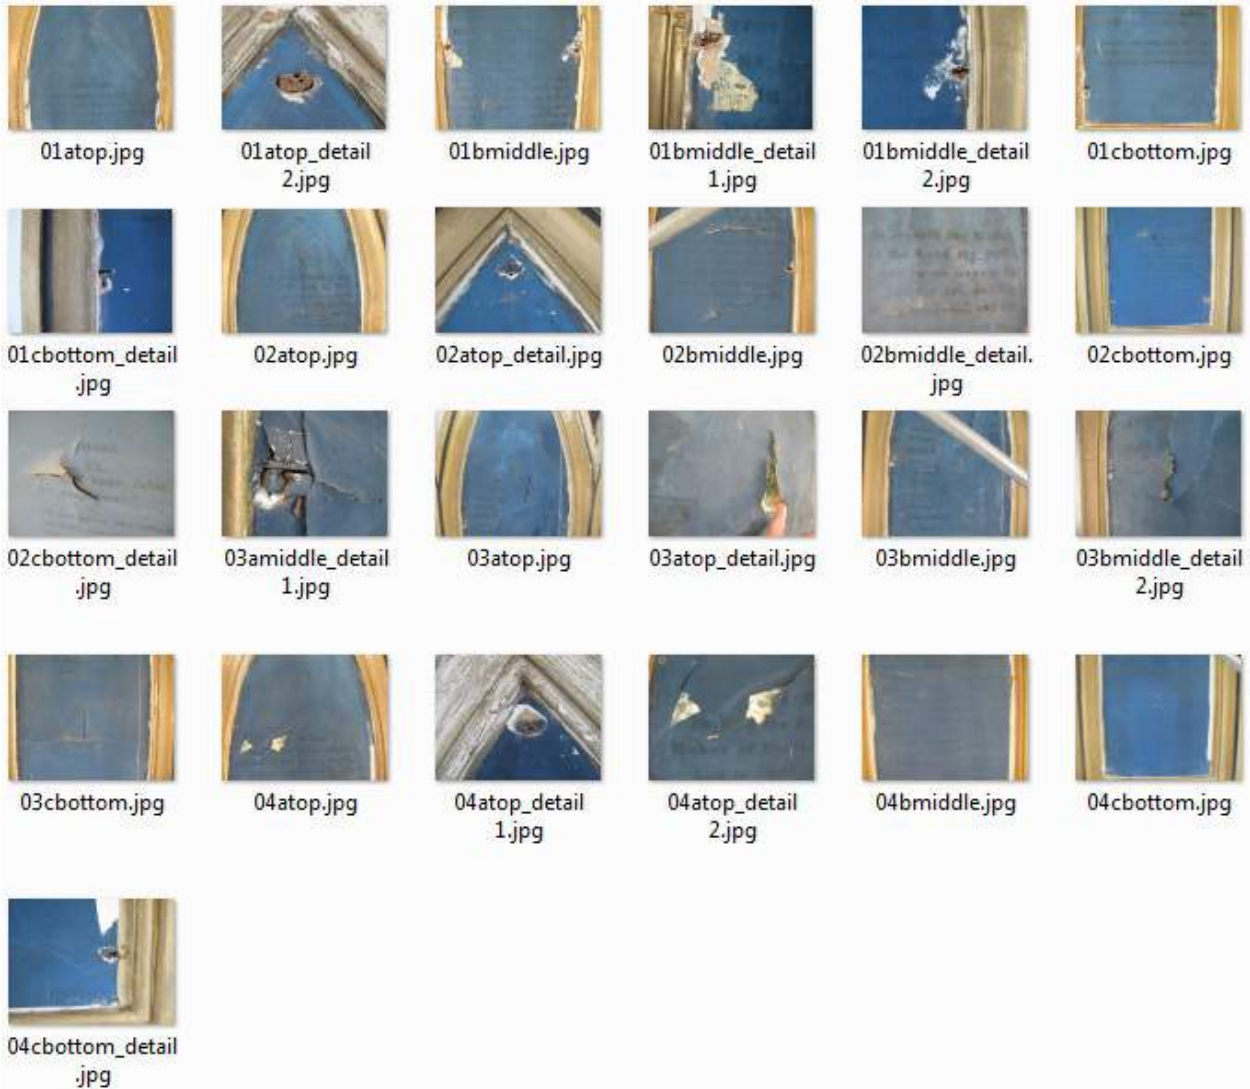
**Digital Treatment Photographs: Paper Mock-ups under Tablets (continued)**

- 04a top. Nicene Creed niche, upper third
- 04a top\_detail 1 Nicene Creed niche, upper third, detail of wood block
- 04a top\_detail 2 Nicene Creed niche, upper third, detail of torn paper
- 04b middle Nicene Creed niche, middle third
- 04c bottom Nicene Creed niche, bottom third
- 04c bottom, detail Nicene Creed niche, bottom third, detail of left nail hole
